Operable Unit 3-13, Group 3, Other Surface Soils (Phase I) Remedial Action Report

July 2007

Idaho Cleanup Project

**Prepared for the
U.S. Department of Energy
DOE Idaho Operations Office**

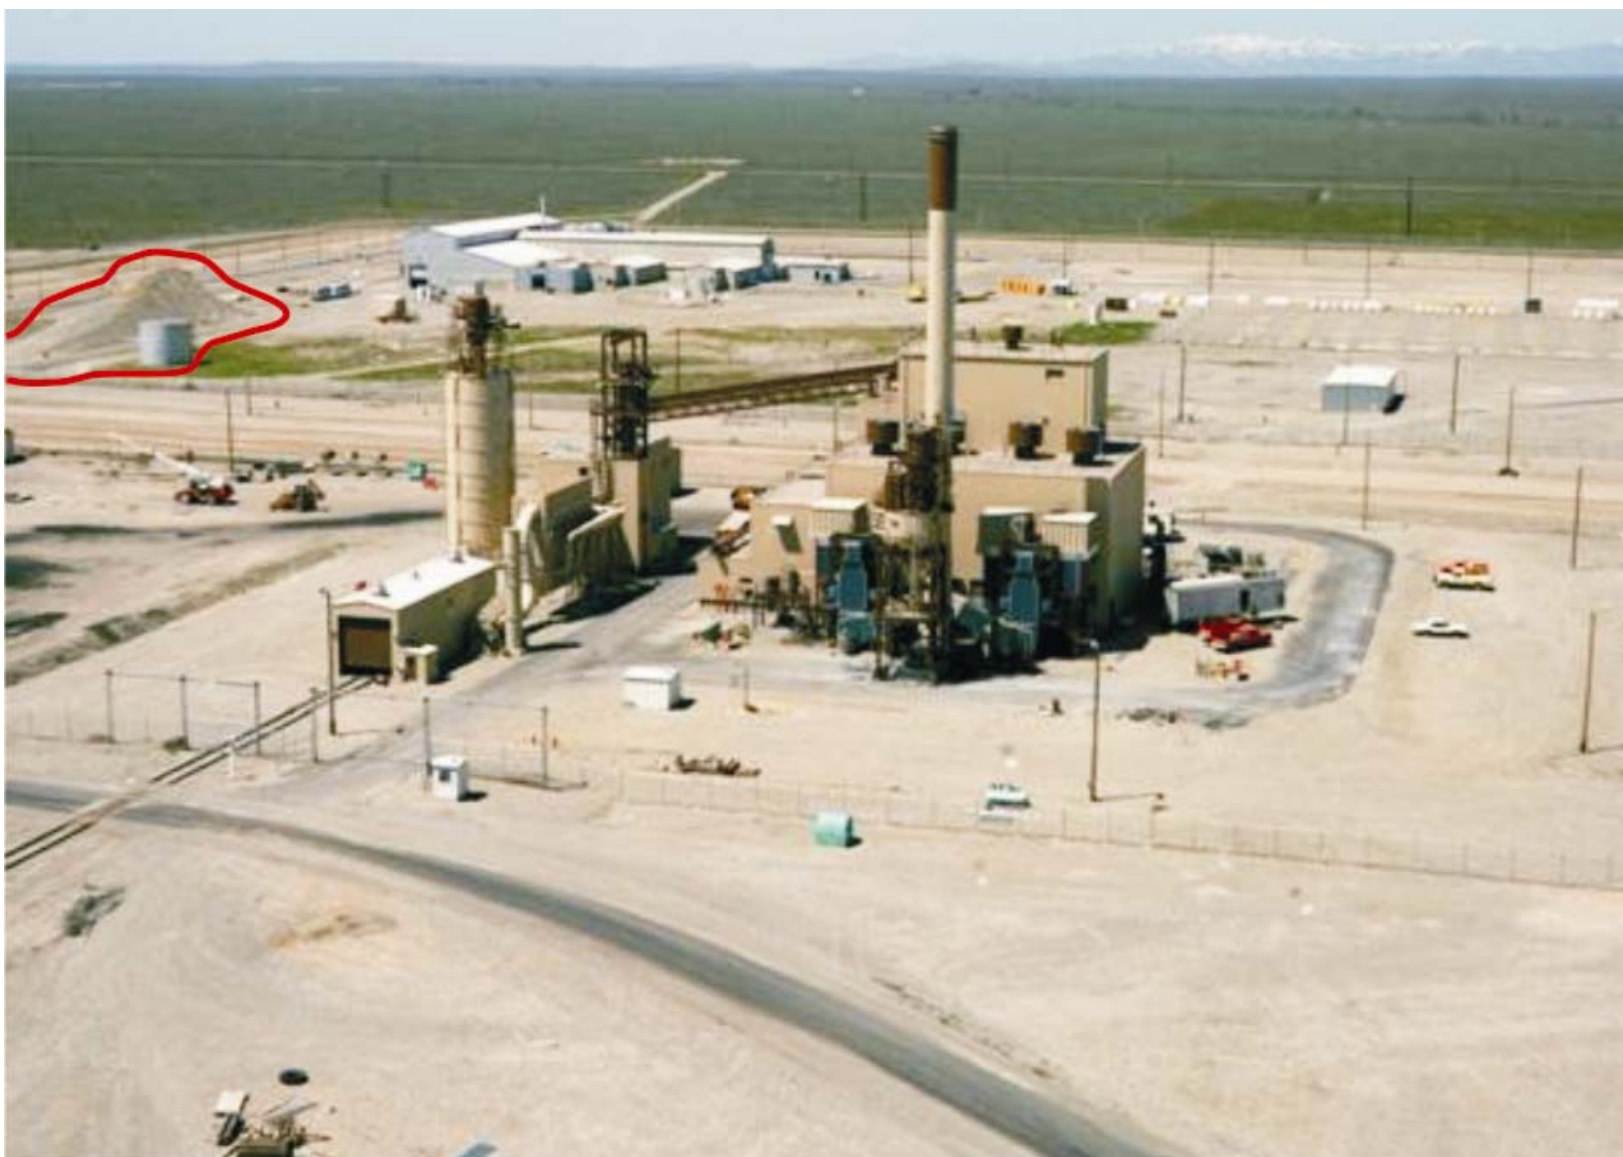
Figure 2-1. Photo of INTEC in 1984. Soil pile on Site CPP-03 area is bounded by the single red line.

The 1984 photograph in Figure 2-1 shows that the WL-102 soil was not stored on the railroad tracks nor on the south and east perimeter roads of the ICPP (i.e., INTEC). Additionally, the WL-102 soil pile was limited to the eastern two-thirds of the CPP-03 area and did not extend over the western one-third of the site. The photo also indicates that the portion of Site CPP-03 north of the railroad tracks was used to store materials and equipment.

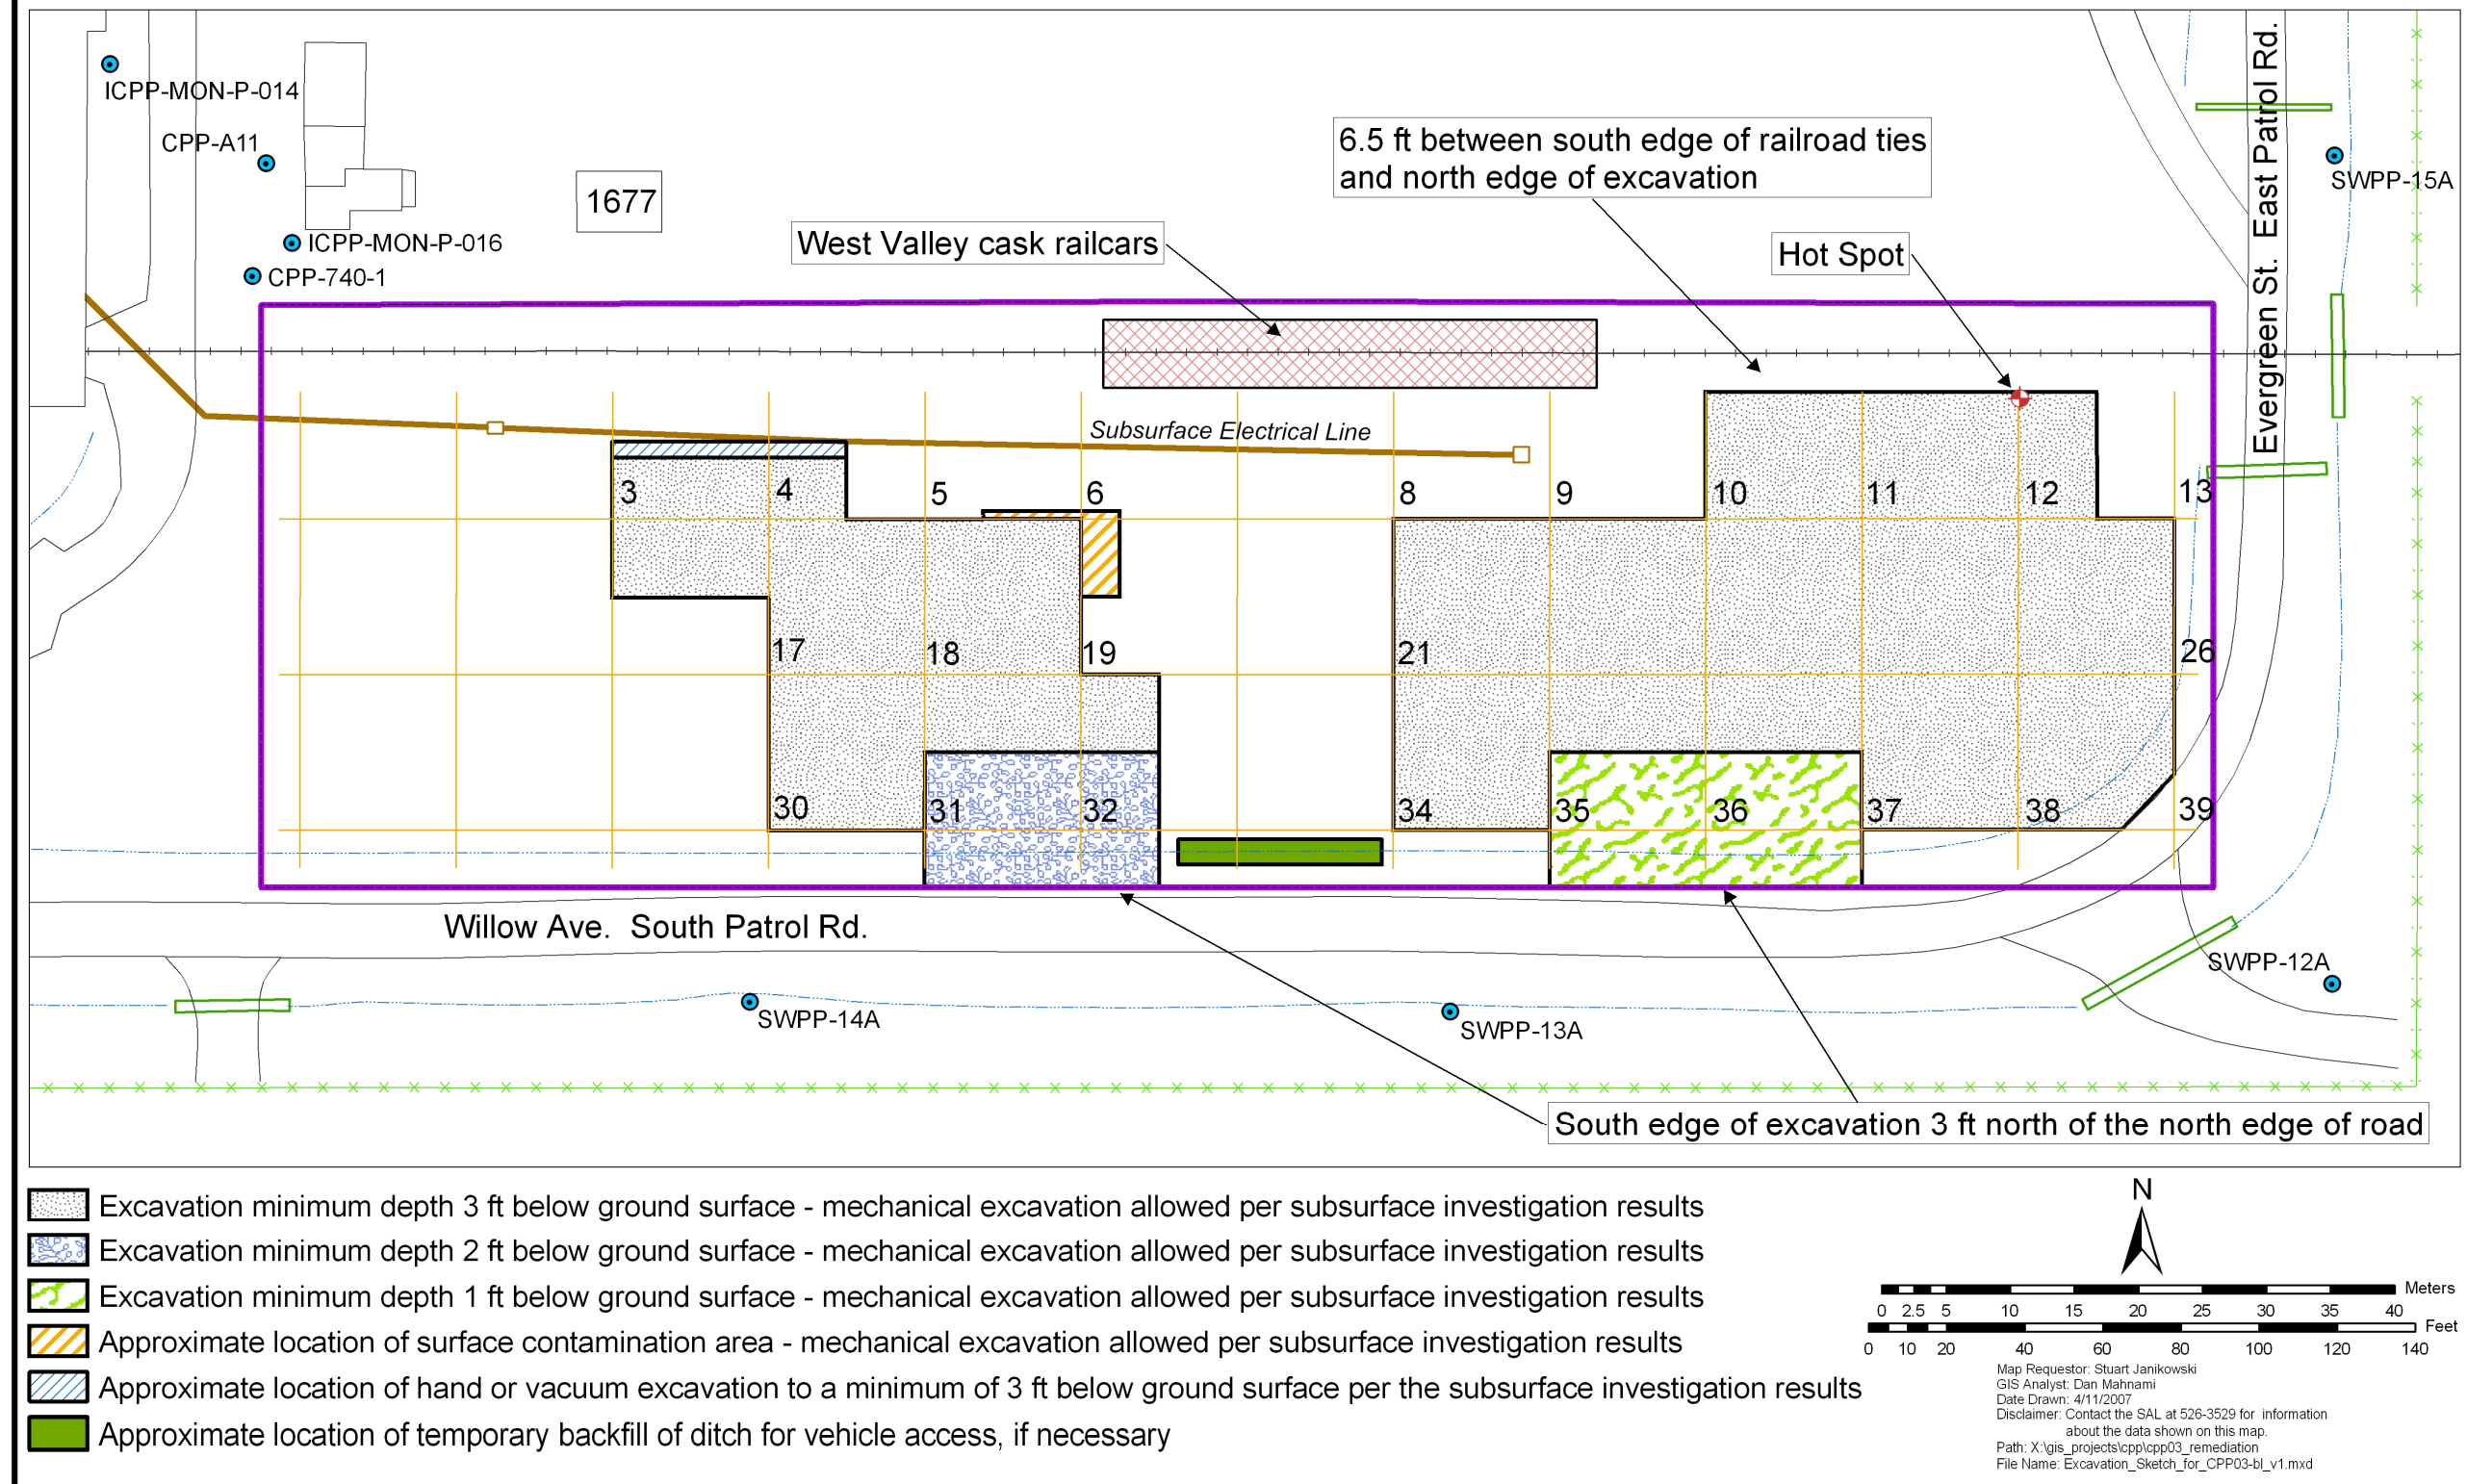
Excavation Sketch for CPP-03 Remediation

Figure 2-2. Dig map for Site CPP-03.

The complexity and hazards associated with excavation increased substantially with this new geophysical information. The ground surface was painted to mark edges of the anomalies; then borders around the anomalies were painted to mark off a 1.5-m (5-ft) distance. To avoid further delays, which would have resulted in halting the excavation for the winter, the site was further partitioned into two types of areas. The first type is where no anomalies would be excavated and where the anomaly density was low enough to be excavated to the 1.5-m (5-ft) boundary from the anomaly without disturbing the anomaly. The second area type was where the anomaly density was high or where anomalies were known to be of a size and conductive (metal) mass corresponding to an object the size of a small cylinder or larger. The former areas remained part of Site CPP-03 and were excavated; the latter areas were grouped into a new site designation, Site CPP-130. Figure 2-3 shows excavation boundaries for Site CPP-03 with the areas in pink redesignated as Site CPP-130.

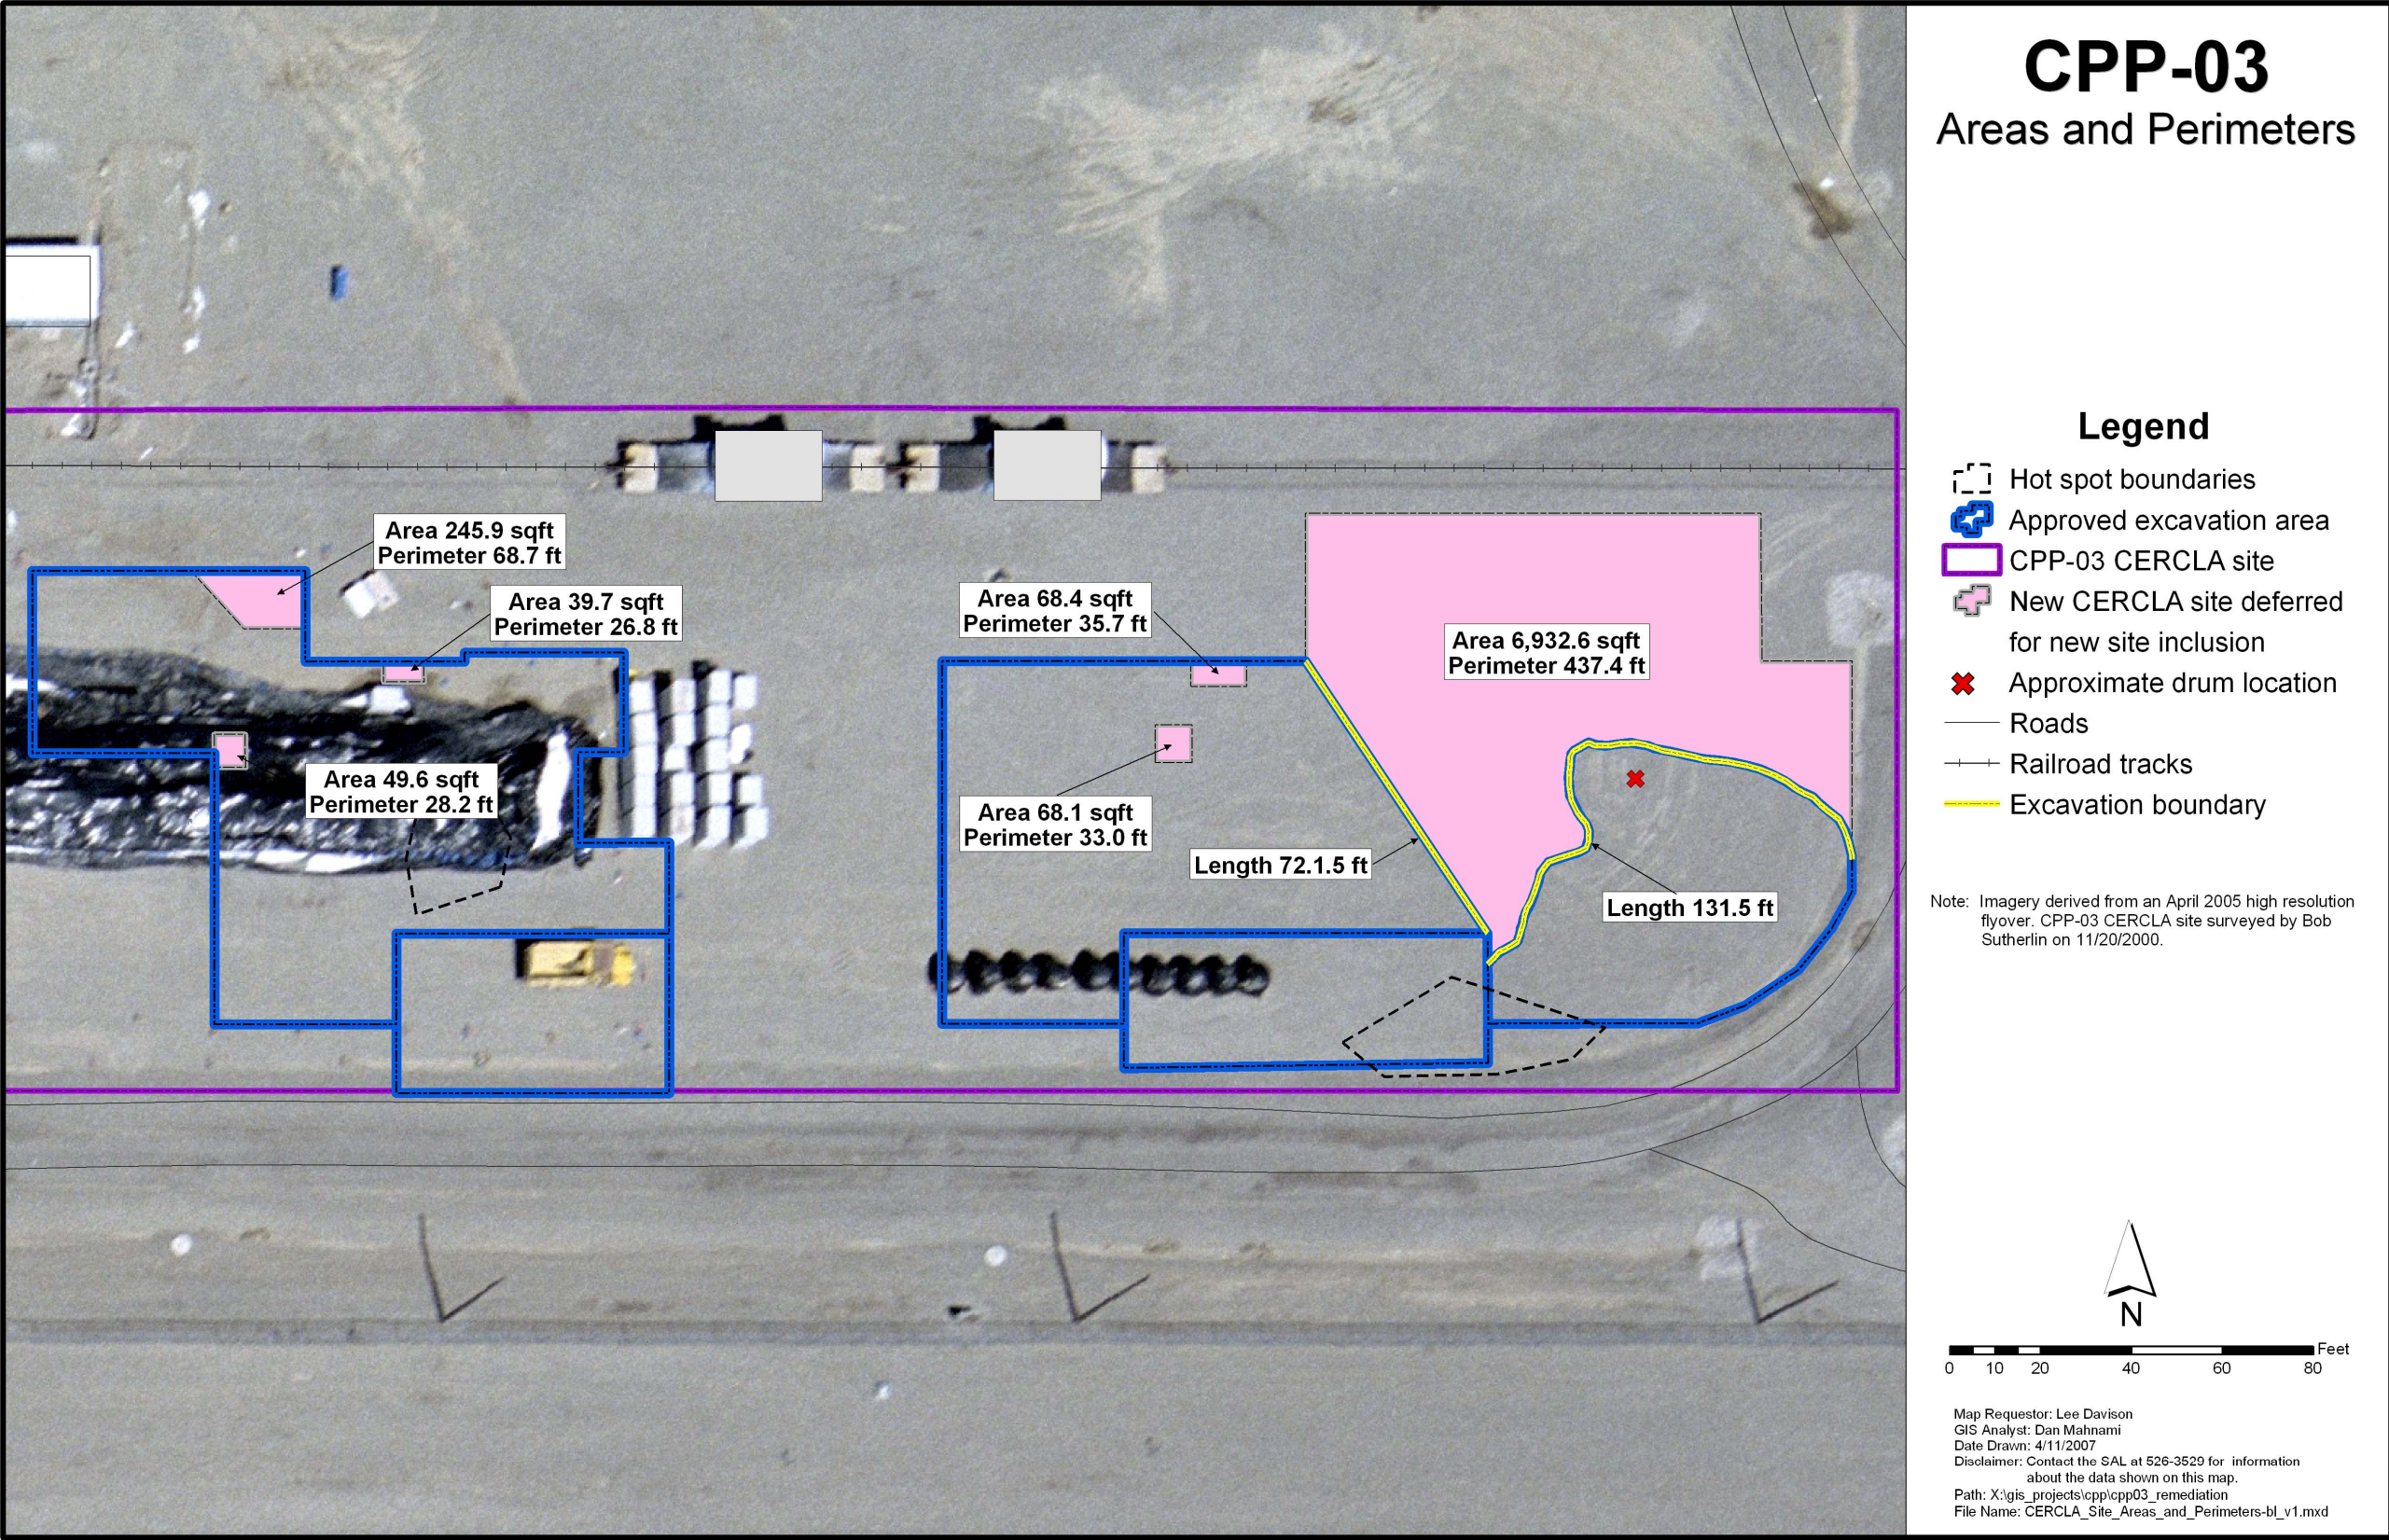
Figure 2-3. Site CPP-03 redefined boundaries in blue outline and new site, CPP-130, initial boundaries in pink.

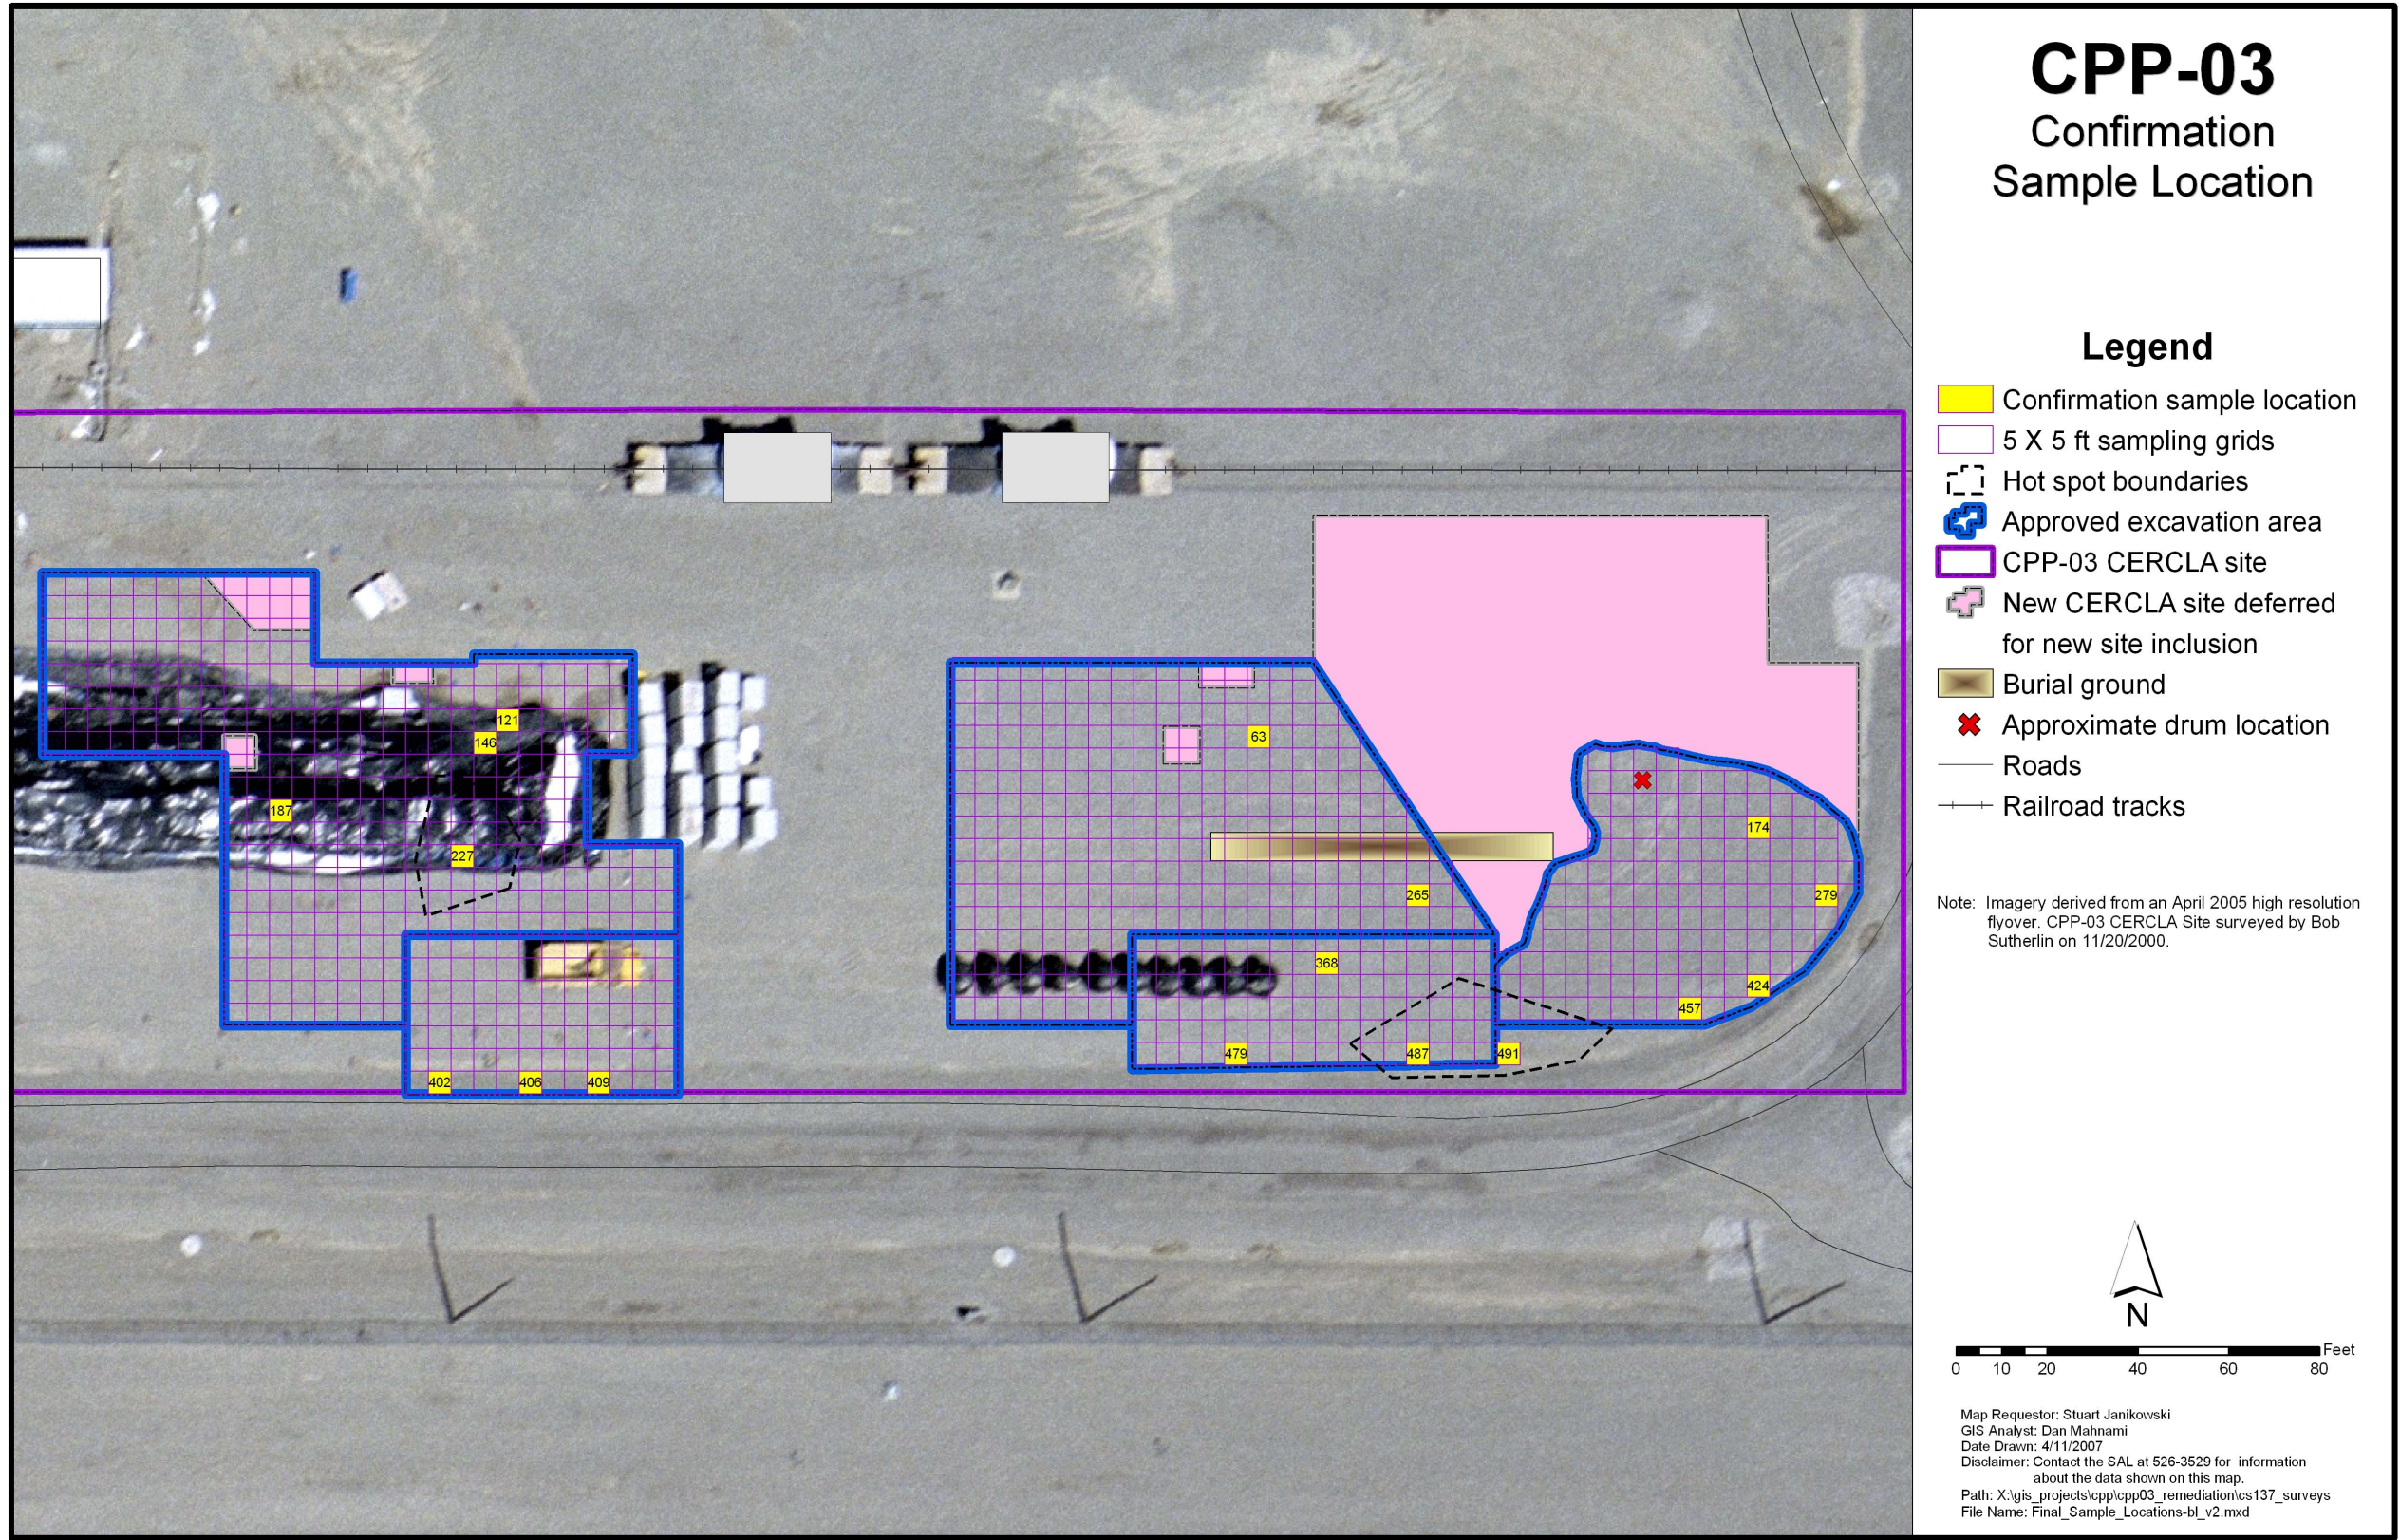
Figure 2-4. Confirmation sample locations for Site CPP-03.

An additional nine biased sampling locations were selected, as shown in Figure 2-4. The six locations designated by Grids 406, 409, 479, 457, 424, and 279 were collected in the ditch area, which needed to be backfilled and contoured to avoid disrupting the storm water drainage system for that region of INTEC. The polygon-shaped areas outlined by dashed lines represent hot spots located with the gamma detector. These areas were excavated further, and three biased soil samples were collected to demonstrate that soil above the remediation goal was removed. Two of the three biased samples were from Grid Area 227 in the western excavation and Grid Area 487 in the eastern excavation. The third biased sample location was in the hot spot in the eastern excavation, which extended beyond the excavation boundary. The excavation then proceeded outside the boundary and encompassed the portion of contaminated soil shown on the map and bounded by the dashed line, but outside the boundary lines. A biased sample then was collected from the Grid 491 area to confirm that the contaminated soil was removed.

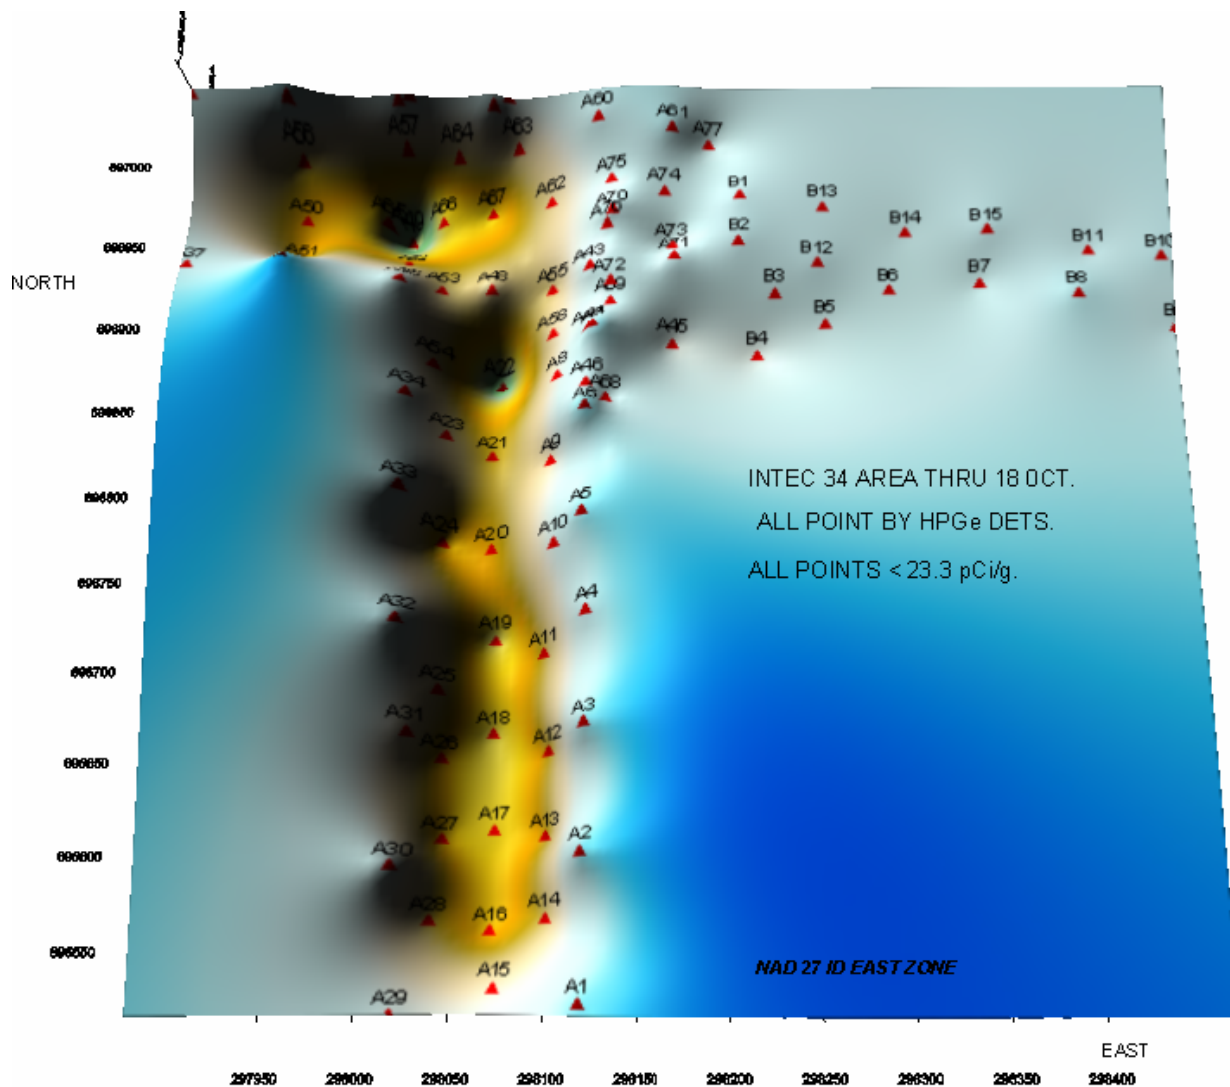
Figure 3-1. CPP-34A/34B high-purity germanium scans showing final excavation topography. Postexcavation locations are shown, all of which are below the remediation goal of 23 pCi/g. Colors were used only to emphasize the contours and do not constitute radiological differences.

3.2.2.1 High-Purity Germanium Results and Maps. Field gamma gross radiation measurements at the CPP-34A/34B areas were taken during excavation. Figure 3-1 contains a diagram of the site showing plotted measurement locations. A Trimble Global Positioning System with survey-grade positioning was used to establish a grid.

Results of the activity showed that nine locations exceeded the Cs-137 remediation goal of 23 pCi/g. These areas were excavated, and radiation measurements were repeated. The pin flags were destroyed during this remediation, so the subsequent gamma scans were performed as physically close as possible to the initial measurement location. Tables B-1 and B-2 (see Appendix B) provide HPGe data and location differences. These measurements were all below the remediation goal for Cs-137 (23 pCi/g), meaning that remediation was complete and confirmation samples could be collected to verify the condition.

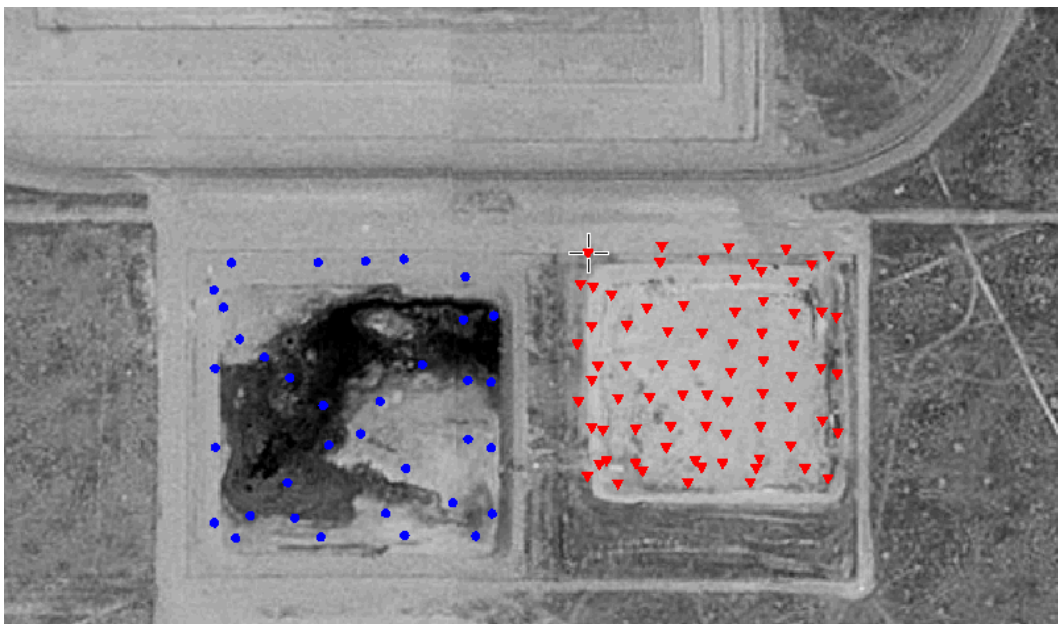
Figure 7-1. Aerial photograph of CPP-67, west and east percolation ponds. The figure shows the data measurement locations and grid pattern (north is up, no scale). Blue dots and red triangles represent locations where HPGe gamma scans were collected on the west and east ponds, respectively.

Gross-radiation measurements for gamma collected at the east and west percolation ponds were completed by November 2004, after completion of all excavation. Figure 7-1 contains an aerial photograph of the two ponds with plotted measurement locations. For the west-side pond, a Trimble Global Positioning System with survey-grade positioning was used to establish a grid shaped like an “X.” Points around the high-water line of the four slopes supplemented this pattern. The same instrument was used for the east-side pond, but a systematic grid pattern on the bottom of the pond was established. Points around the high-water line of the four slopes also supplemented this pattern.

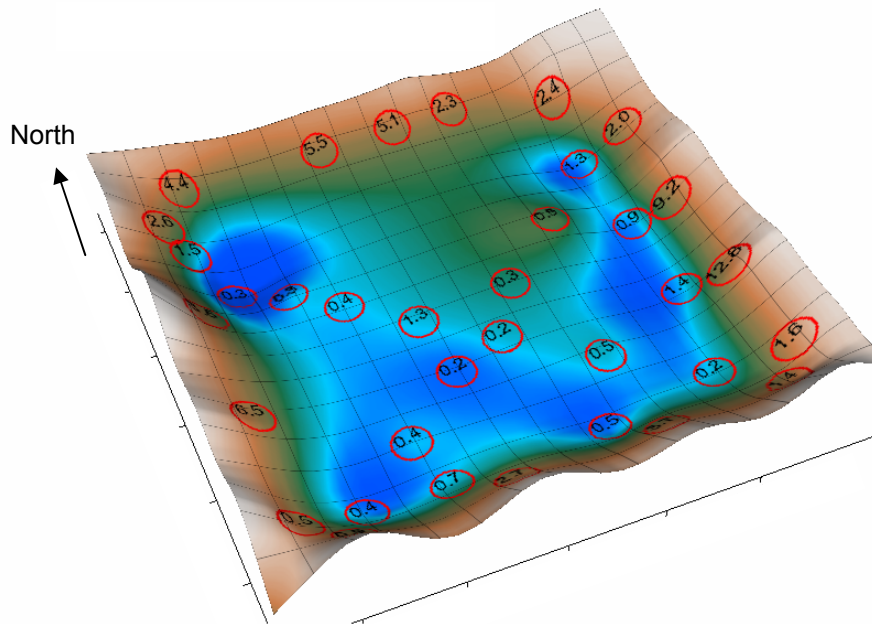
INTEC WEST – STATE PLANE 27 ID WEST

Figure 7-2. West percolation pond showing HPGe readings for Cs-137 in pCi/g (no scale). Colors and shading are used only to enhance the contours and do not constitute radiological differences.

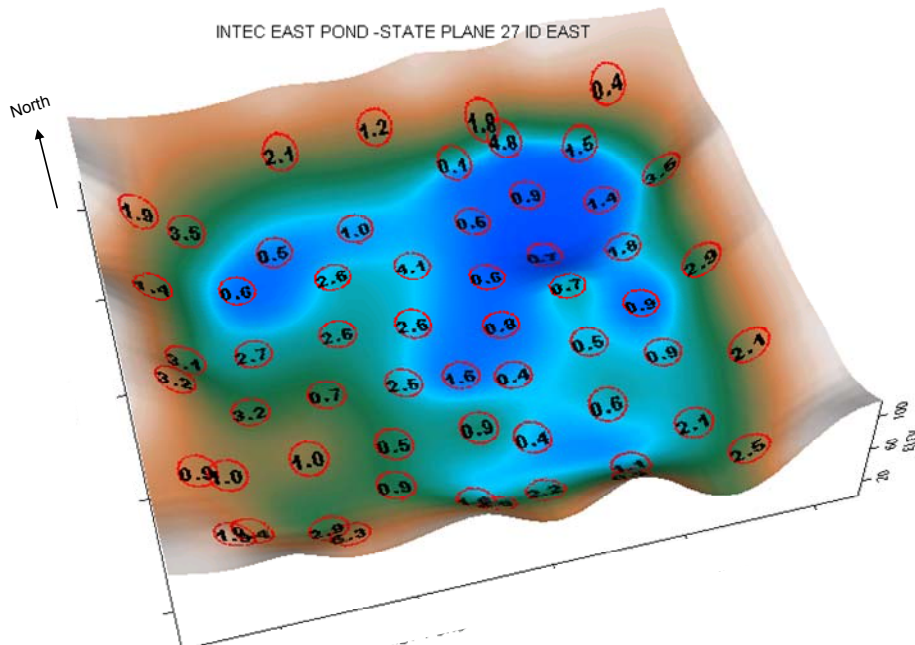
Figure 7-3. East percolation pond showing HPGe readings for Cs-137 in pCi/g (no scale). Colors and shading are used only to enhance the contours and do not constitute radiological differences.

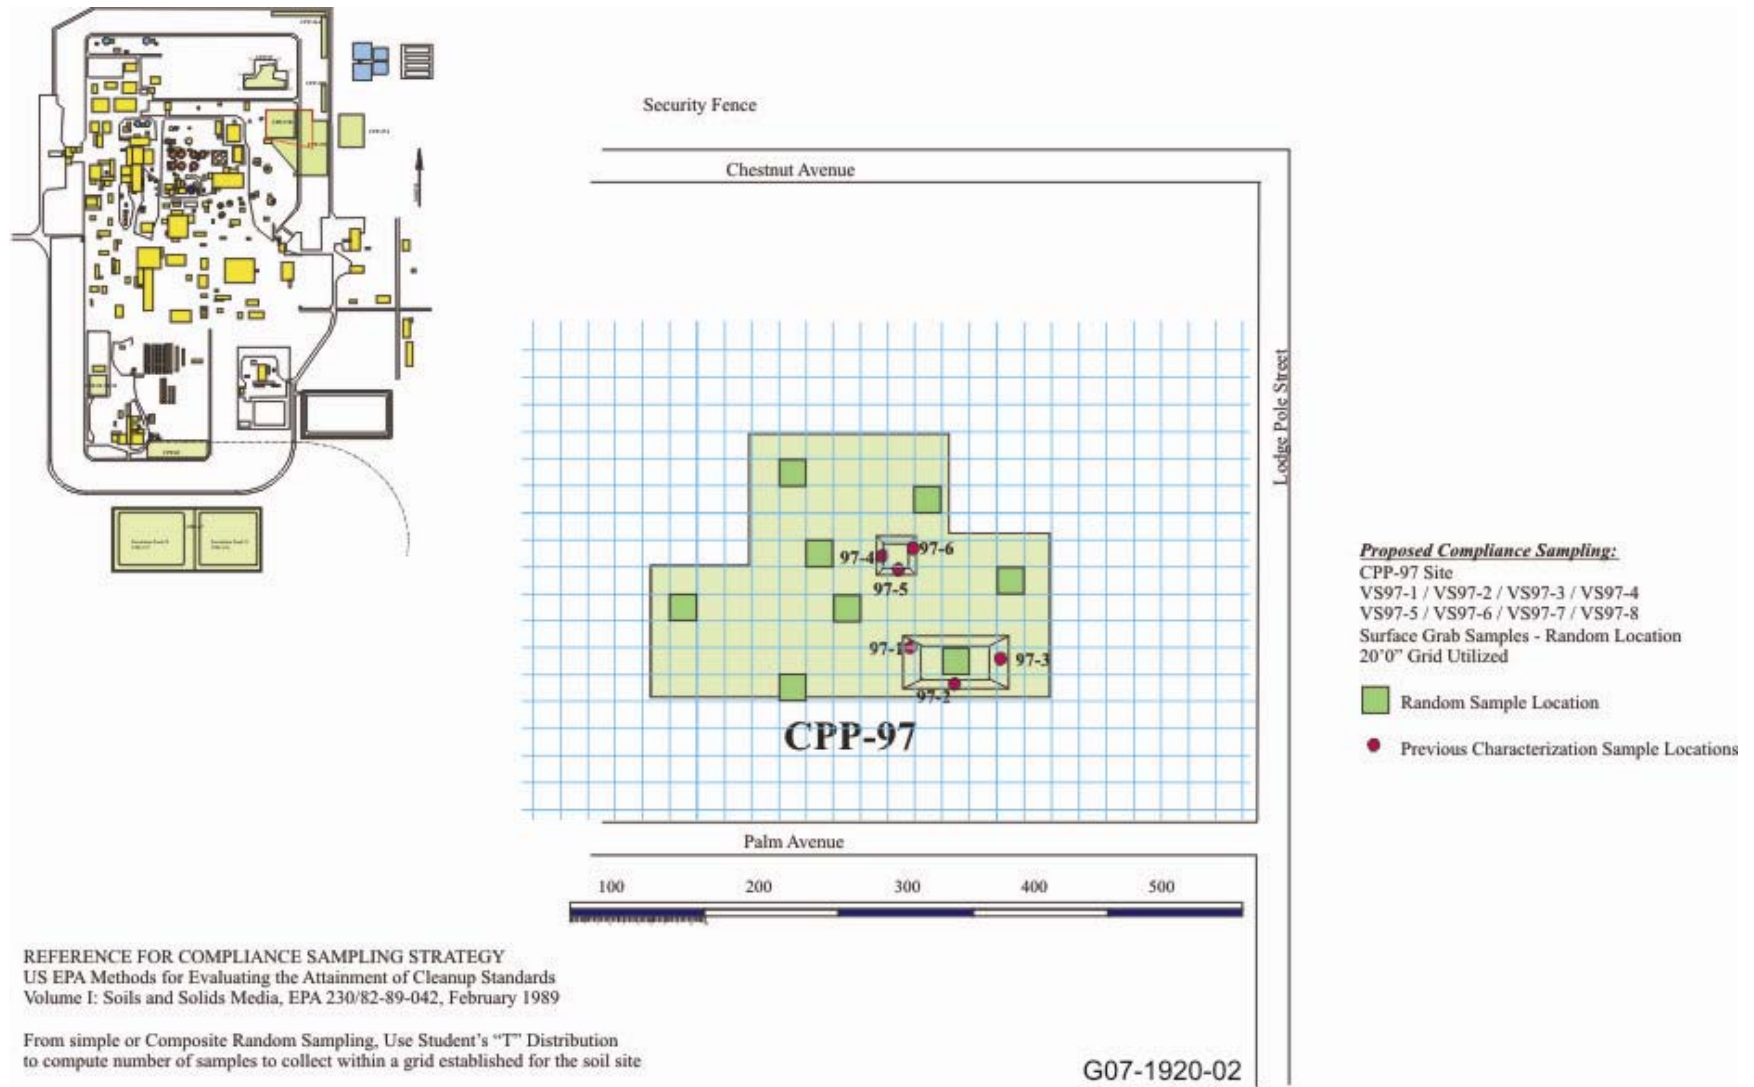
Figure 9-1. Confirmation sampling locations for Site CPP-97.
